Peake's Point Horizontal Curve Study

Gulf Breeze, Florida

Introduction

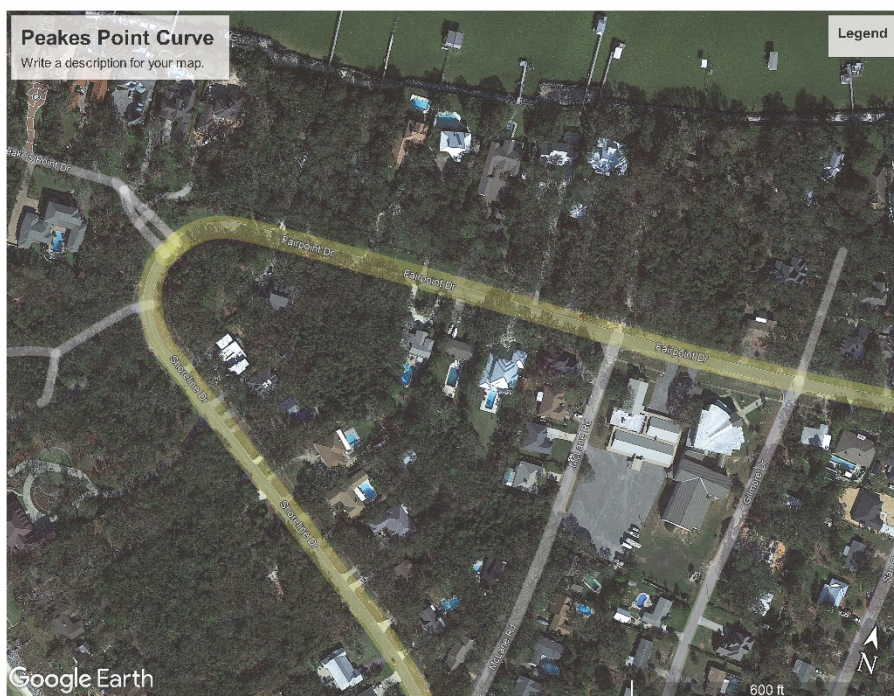
The roadway is shown in the aerial image below.

Fairpoint Drive and Shoreline Drive are two-lane undivided county roadways that contain a sharp horizontal curve at their intersection with Peake's Point Drive. All roadways have flush grass shoulders, and have centerline and edge line thermoplastic pavement markings. Centerline retroreflective pavement markers (RPM's) follow FDOT specifications installed at 40 ft spacing. The study extended from McLane Rd on Shoreline Drive through the curve and back to McLane Rd on Fairpoint Drive.
